(SIXTH QUARTERLY REPORT)  
PRESSURE MEASURING SYSTEMS FOR  
CLOSED CYCLE LIQUID METAL FACILITIES

Consolidated Controls Corporation  
Bethel, Connecticut

SIXTH QUARTERLY REPORT  
June 1, 1965-August 31, 1965

14205  
Continuing development of a thermionic diode pressure transducer for liquid metal applications is described. Two test models were fabricated and installed in the Vacuum Test Facility. One of the models incorporated the C-129Y double convolution pressure capsule previously tested using the optical technique. A cross-sectional cut was made of the representative Nb-1Zr/Lucalox seal which recently underwent life testing. Analysis of the cross-section indicates that seals fabricated by this technique will meet the performance requirements for temperature and internal pressurization. The 500 hour potassium compatibility test was completed. After the test, the four test pressure capsules were found to be still leak tight. Metallographic examination showed no evidence of potassium attack in the capsule interior. Initial work on the transducer signal conditioning equipment established the various functional blocks of the system. The differential pressure transducer effort was

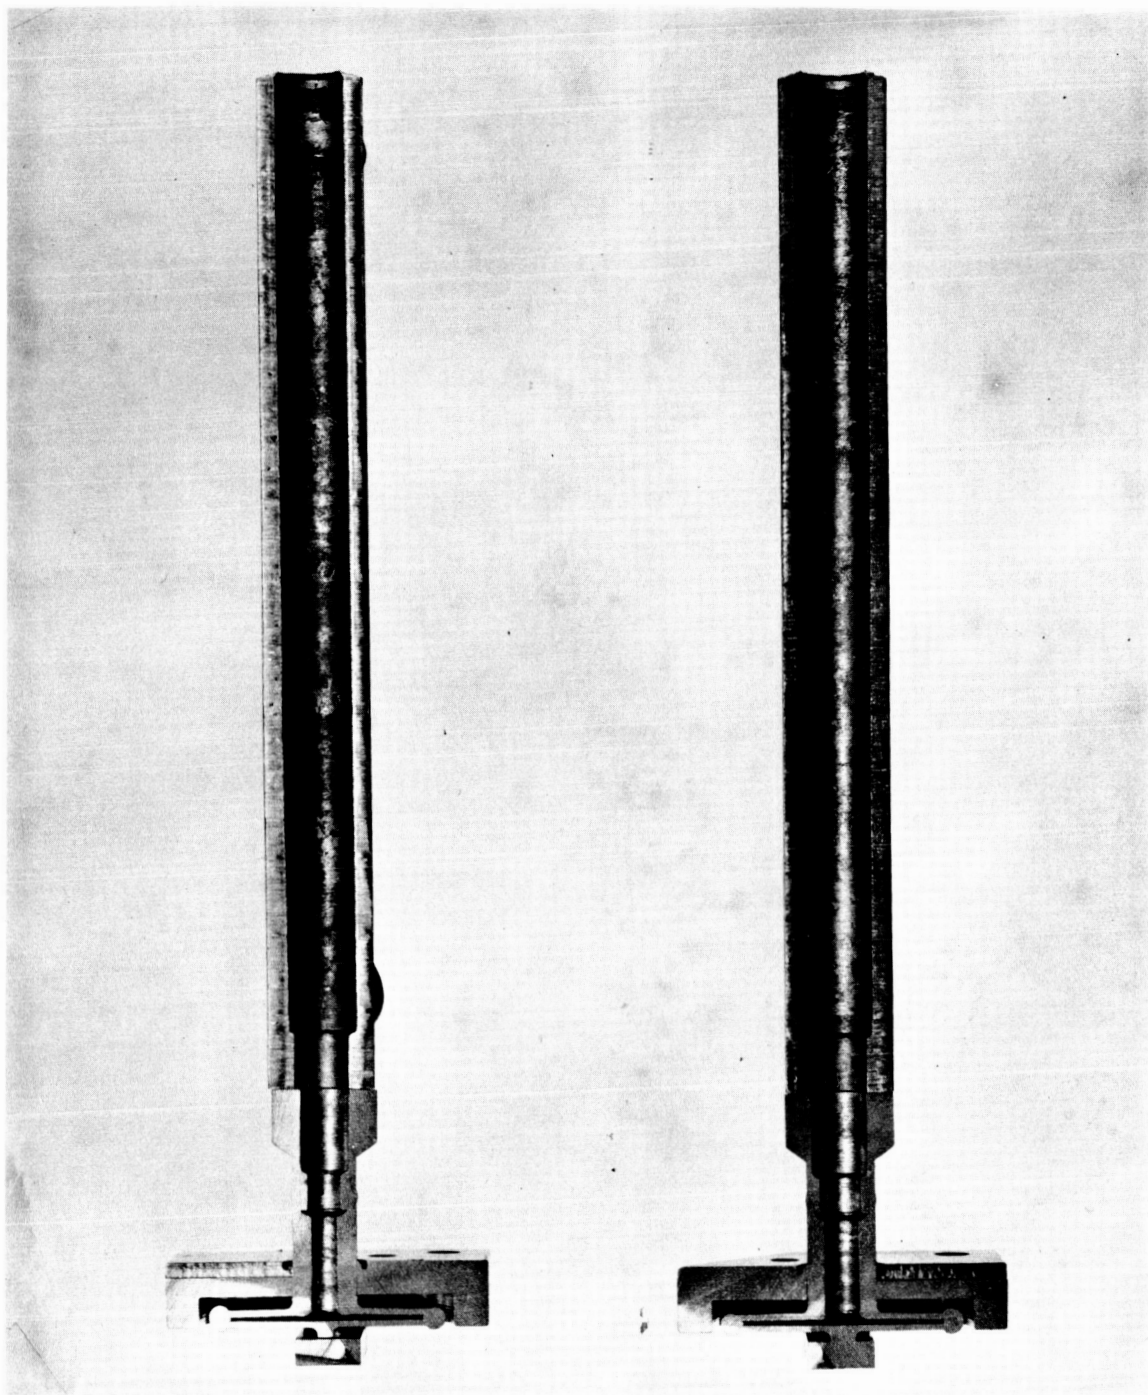
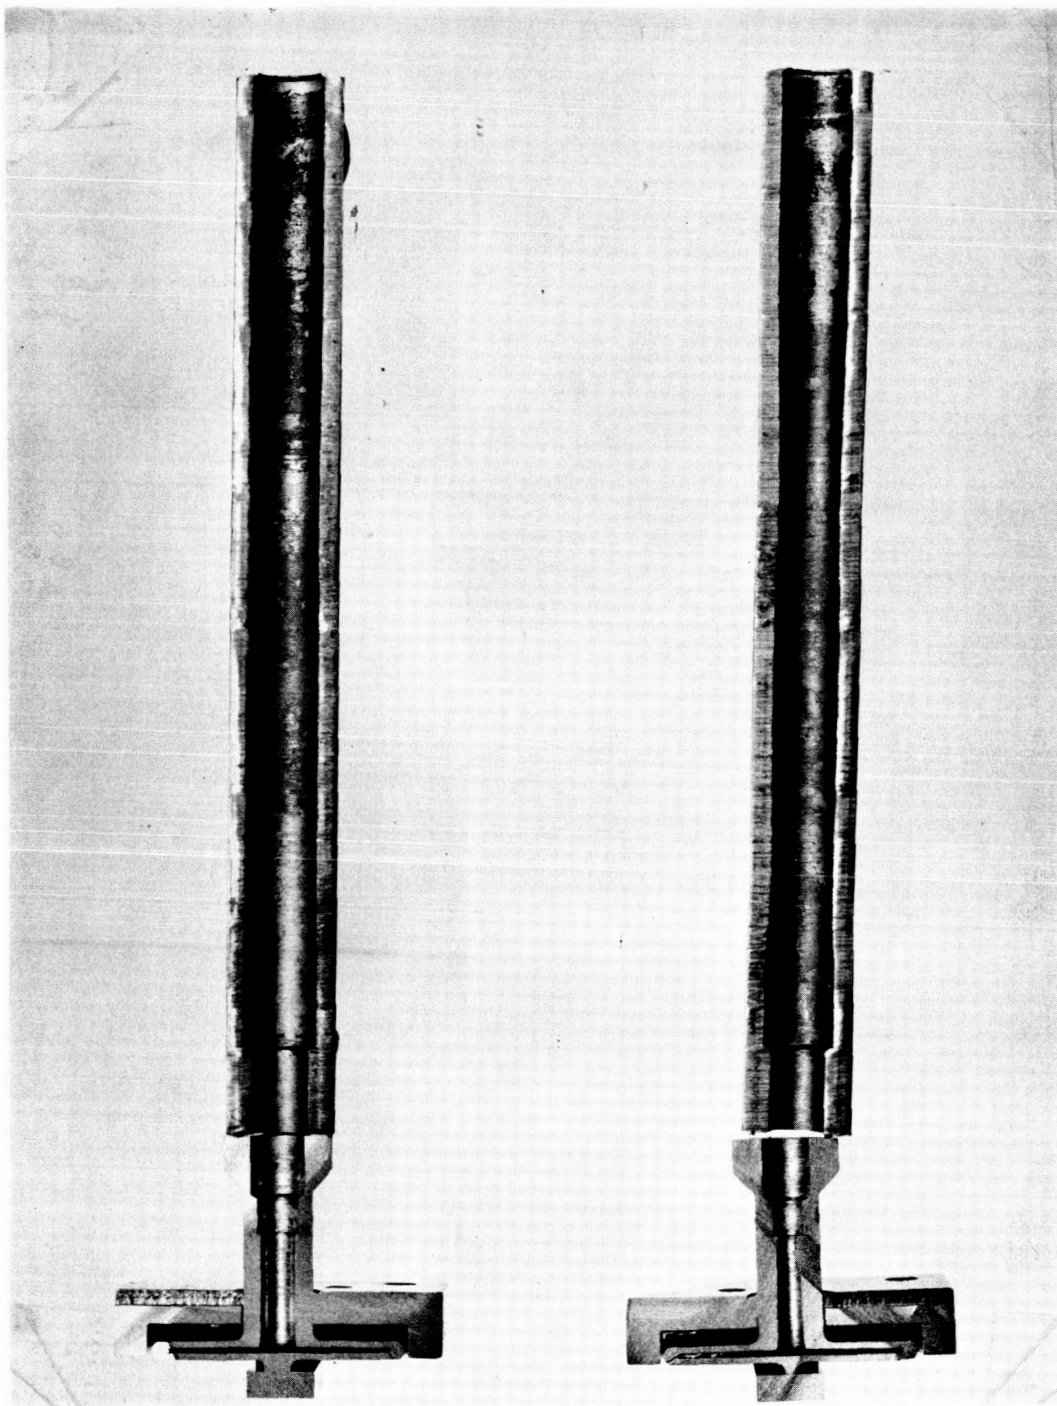
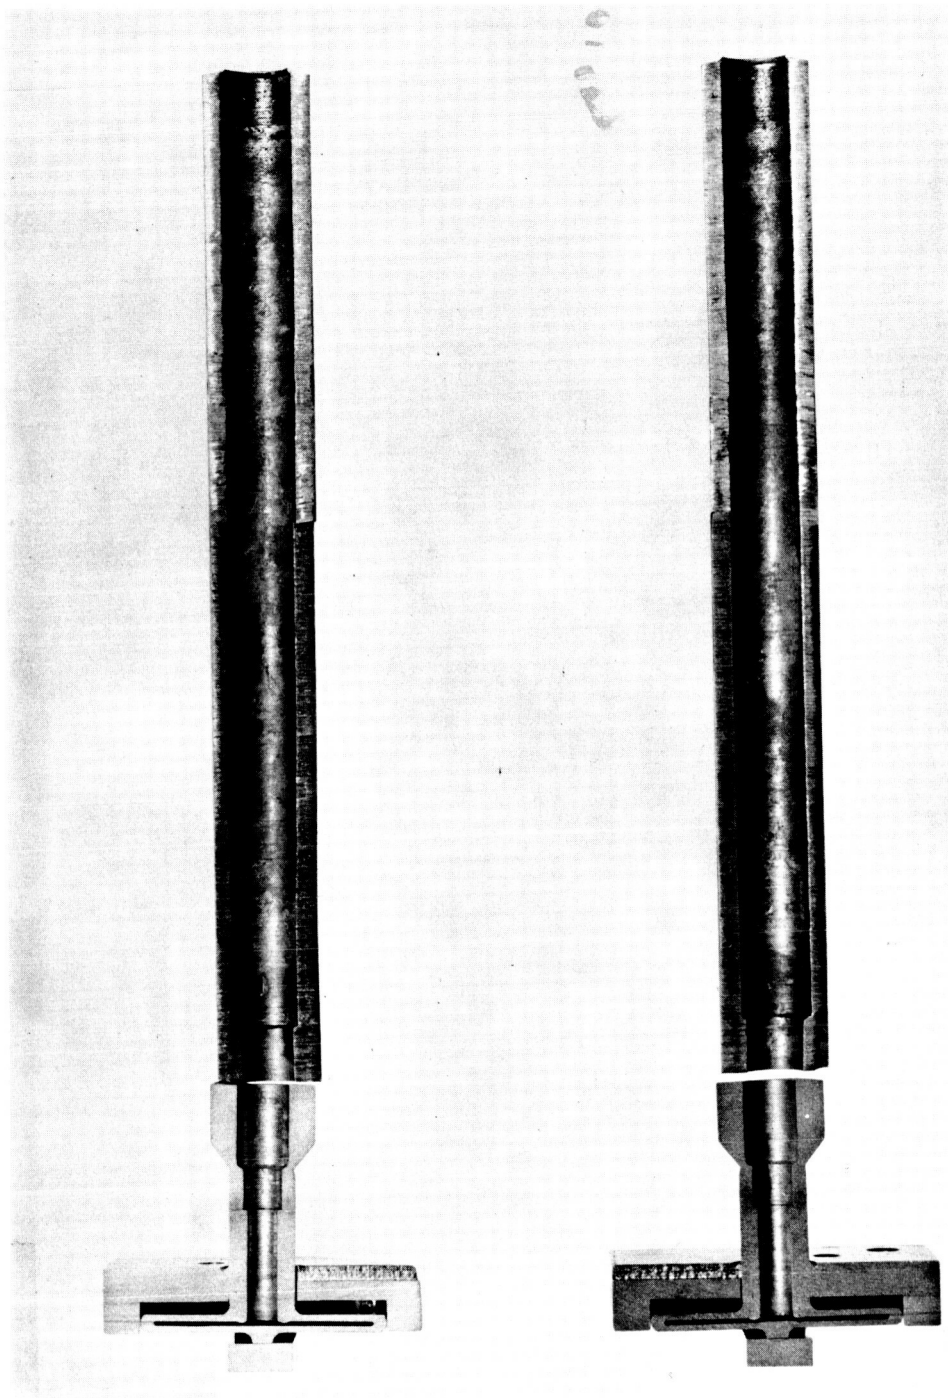
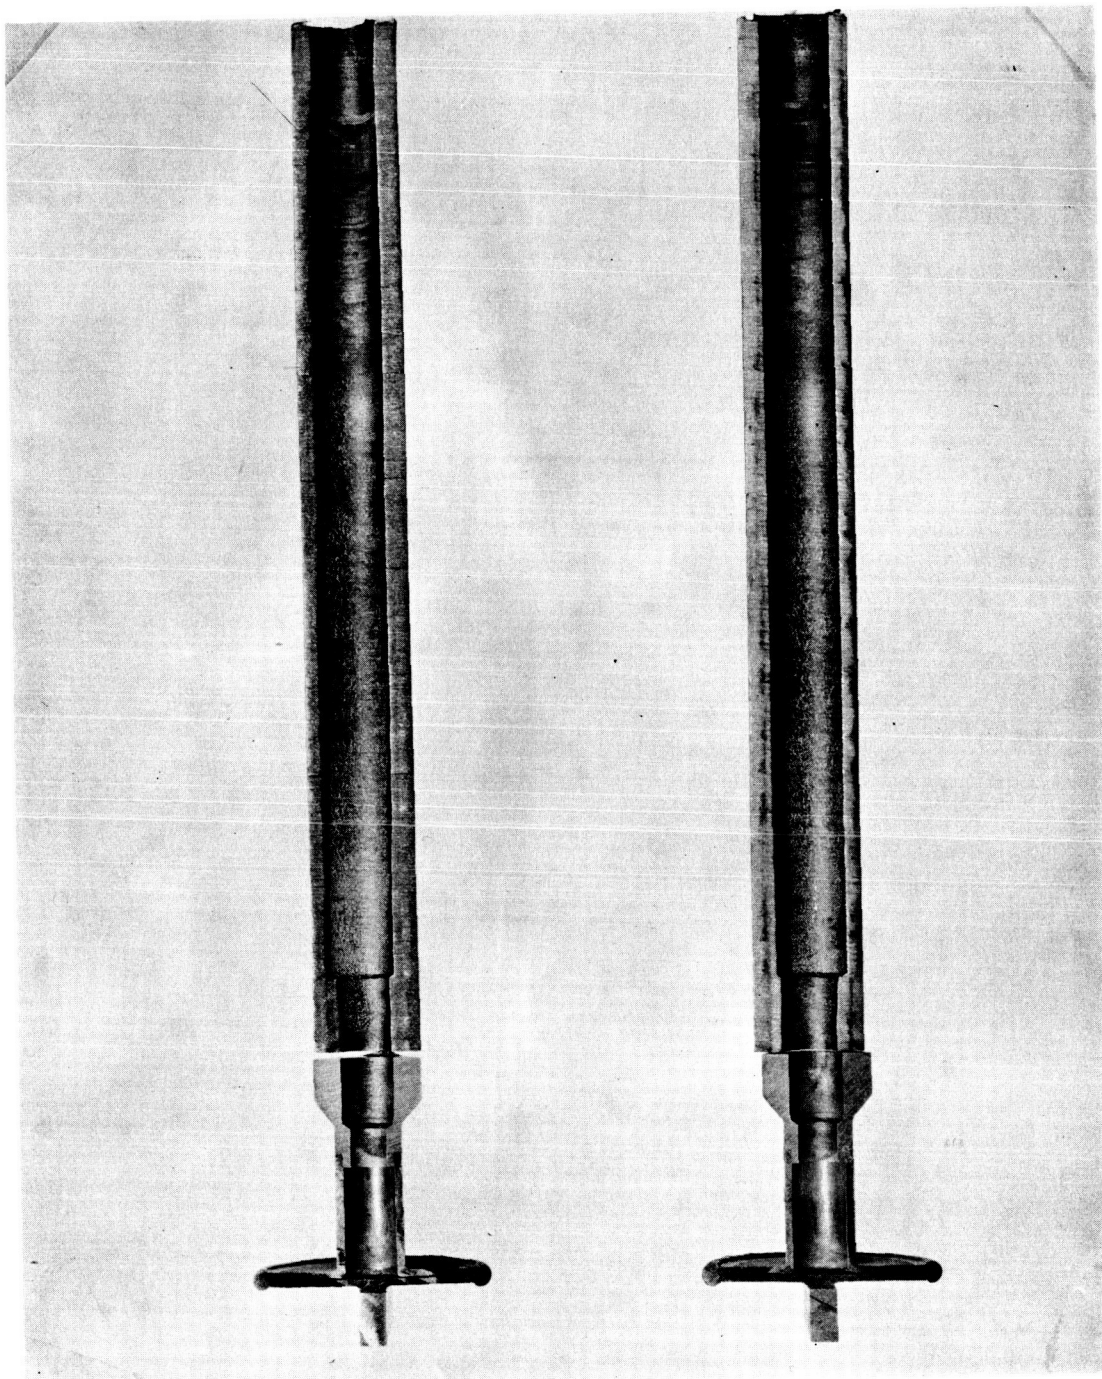
C-129Y compatibility capsule in "as sectioned" condition after test. (Full Scale)

FS-85 compatibility capsule in "as sectioned" condition after test. (full scale)

T-222 compatibility capsule in "as sectioned" condition after test. (Full Scale)

W-25 Re compatibility capsule in "as sectioned"  
condition after test. (Full Scale)

Figures 24 to 27 show the pressure compatibility capsules after sectioning. It is seen that in each case the lower portions of the pressure capsules are clean and almost free of corrosion while the upper portions show small amounts of a black corrosion product. As described above, this black coating could have been removed in some cases during sectioning the capsules with a water-cooled cut-off wheel. In the C-129Y capsule (Figure 24) and the FS-85 capsule (Figure 25), the boss in the center of the lower diaphragm was found to be pressure-welded to the limiting stop after the test at 1800°F.

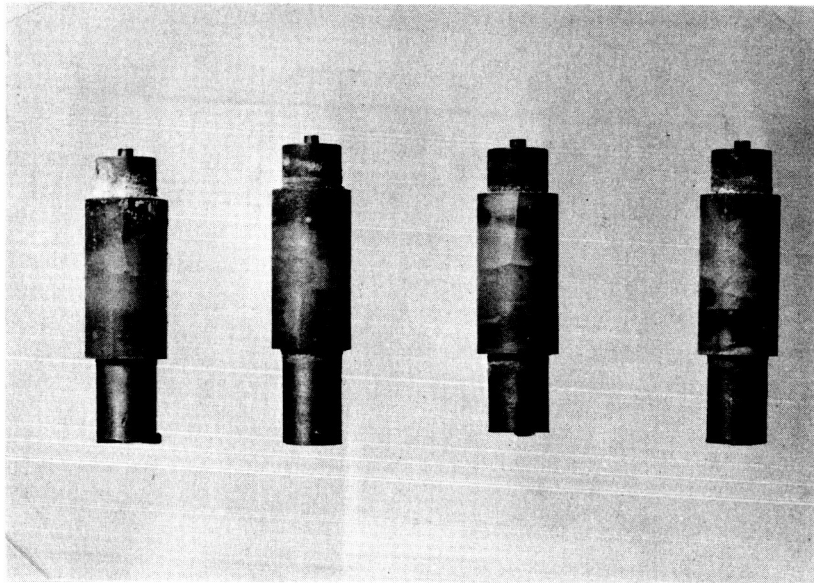
**FIGURE 29**

**Electrical Terminals with lower end caps removed after test. (3X Magnification)**

The four terminals were then opened by machining off the FS-85 caps on the lower ends of the terminals. Photographs of the terminals in this condition are shown in Figure 29. Two of the terminals when opened were found to contain the white potassium compound observed on the outside of the terminals. All four

terminals were then helium leak tested; three were found to be leak-tight and one to have a leak. Of the three units that were found to be leak-tight, one was filled with the white potassium compound. Apparently, the electron-beam weld joining the small cap to the terminal leaked, because the potassium compound was only present in the very bottom of the terminal. Thus, it appears that three out of the four terminals were leak-tight after the test, even though the outer band of Lucalox was cracked.

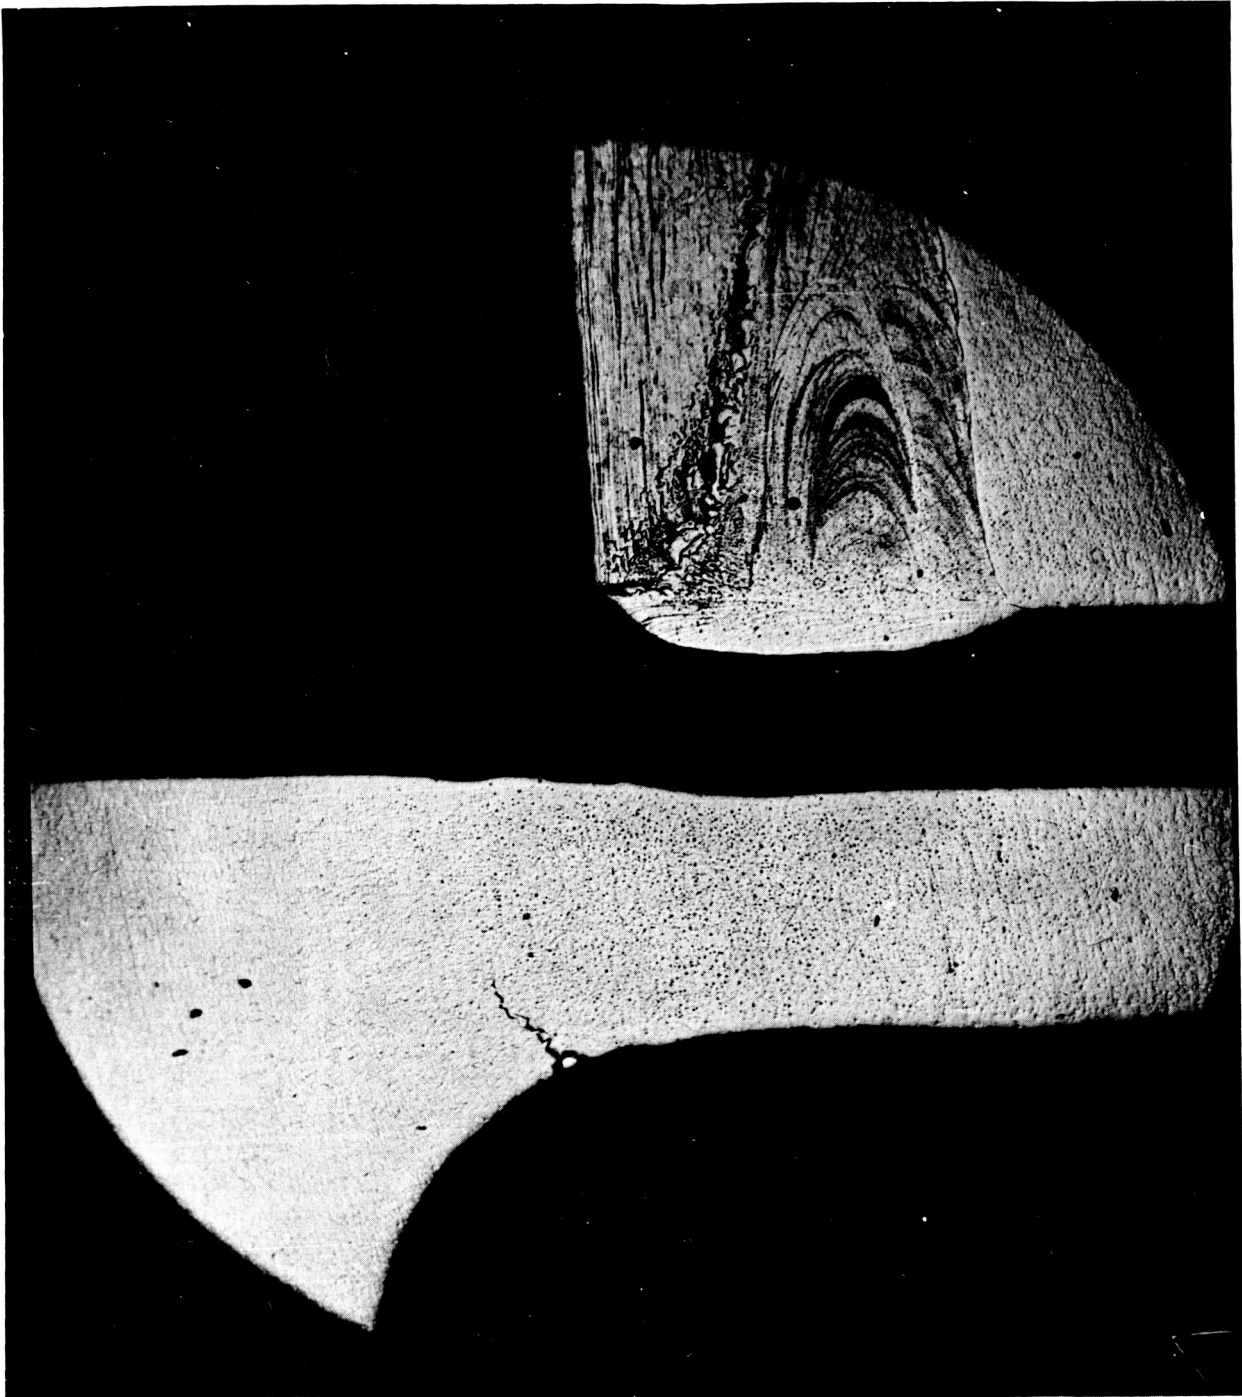
FIGURE 38

Intergranular crack in T-222 compatibility capsule at shoulder of boss in center of diaphragm. (25X magnification)

Examination of the cross-sections of all the pressure capsules at up to 400 X magnification showed no evidence of attack at the inside of the capsules by the potassium. The only abnormal feature found was that the capsule boss was pressure welded to the yokes as described above. In addition, an intergranular crack was observed in the outer surface of the T-222 capsule. This intergranular crack originated in the radius of the internal corner between the central boss of the lower diaphragm and the diaphragm proper, and extended inwards at a 45° angle approximately one-third of the way through the diaphragm. (See Figure 38). Apparently a machining fault provided a stress concentrating notch in the vicinity of the boss, causing the crack.

Figure 38 shows the intergranular crack in the T-222 capsule diaphragm.

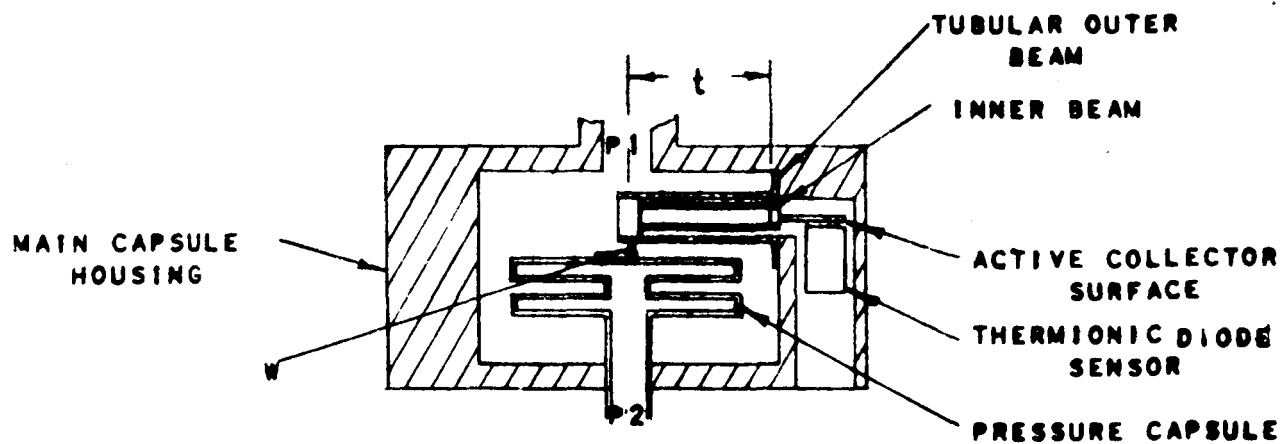
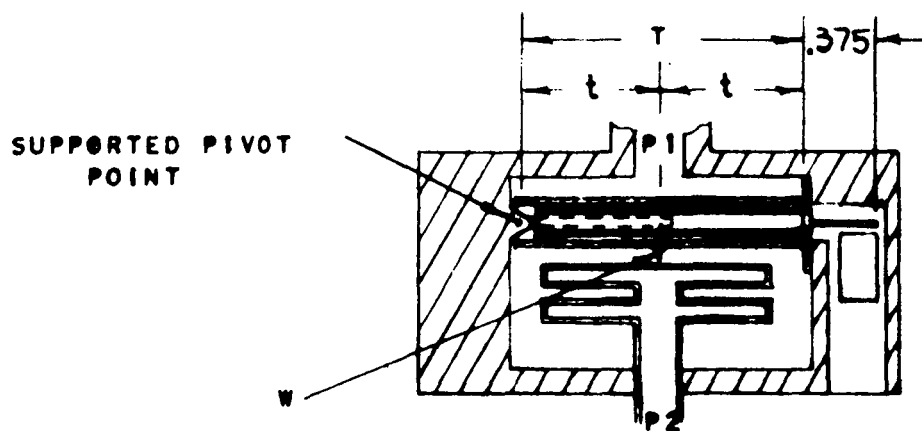
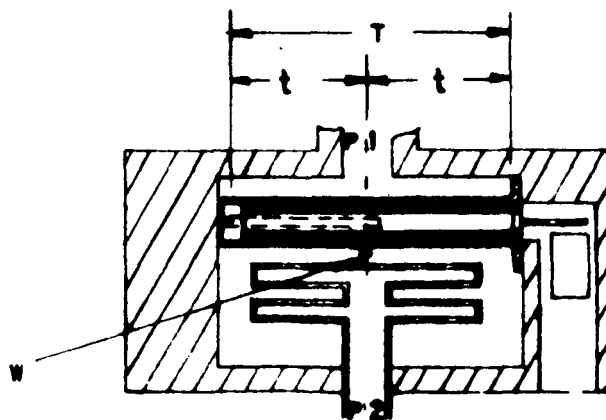
FIGURE 40

CASE I - CANTILEVER, END LOAD

CASE II - END COUPLE, SUPPORTED PIVOT

CASE III - END COUPLE AND END LOAD

# DIFFERENTIAL PRESSURE TRANSDUCER CONFIGURATIONS

Results of the vibration tests of the beam in air showed that the Case III beam configuration had relatively broad resonant peaks between 220-250 cps, 700-820 cps, and 1400-1600 cps, and a sharply defined resonance at about 330 cps. Should these resonant peaks exist while the beam is in operation, the transducer output would be in considerable error. However, in operation the beam will be immersed in liquid metal, and therefore, subject to greatly increased damping conditions. For this reason, the resonant motion of the beam will be certainly minimized if not eliminated completely.

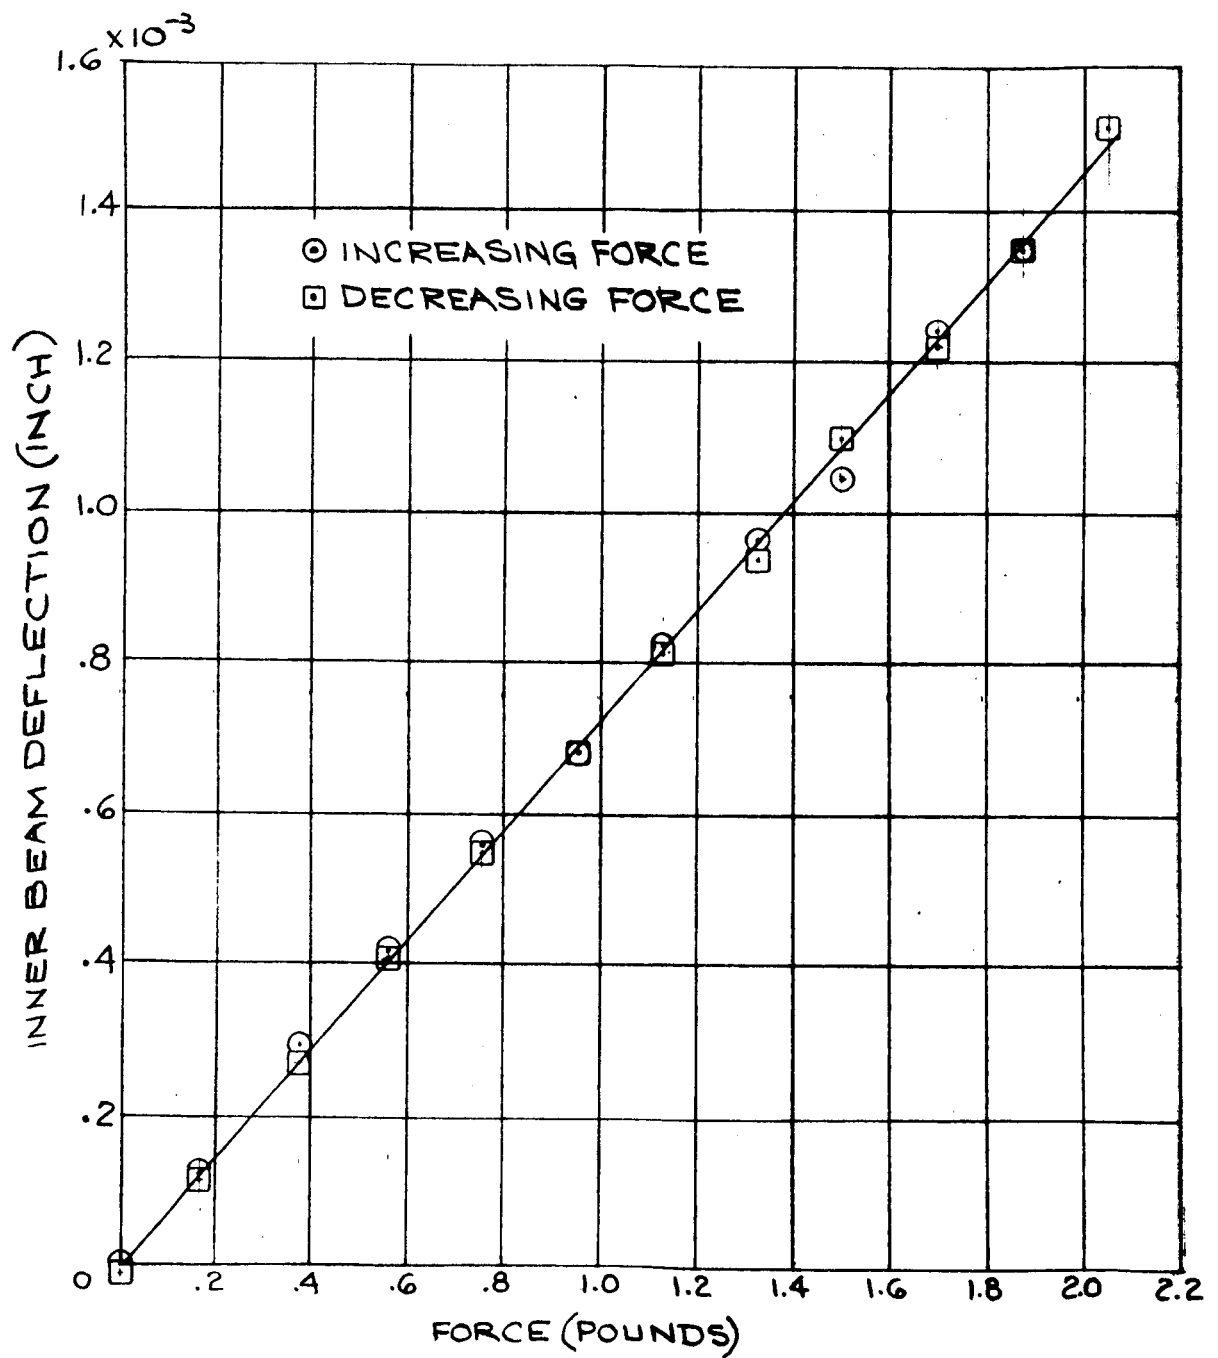
FIGURE 42  
DIFFERENTIAL MOCKUP  
FORCE-DEFLECTION CHARACTERISTIC

and inner beams together had failed and the inner beam had become loose. A second mock-up was made using the same size inner and outer beams but the assembly was welded together. Test results obtained from the second mock-up indicated that for an applied force of one pound, an inner beam deflection of about 0.0002 inch was obtained.
